RECORD OF LAND CORNER MONUMENTATION

EAST 1/4 CORNER OF SECTION 20, T. 7 S., R. 46 E., W.M.

FILED January 24, 2024
BAKER COUNTY SURVEYOR
SURVEY NO. 7-46-168

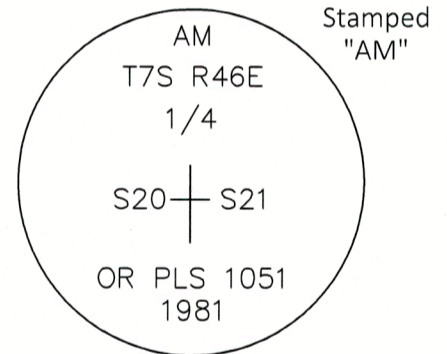
AMENDED MONUMENT DIAGRAM

Found a 2 1/2" galvanized iron pipe with a 2 1/2" brass cap marked as shown in amended monument diagram, projecting 5" above ground with a steel fence post northwest 3 ft with attached USFS 54-4 sign. Monument lies approximately 100 ft. south of Forest Service Road 6625270 and approximately 60 ft. north of an old logging road on a steep north facing slope.
From which bearing trees by Barbour:
A fir stump, bears N.57°E., 32.1 ft., rotten with visible scribing.
A fir, 24" dbh, bears N.71°W., 31.4 ft., with double healed blaze in good condition.

Observations of the section corners to the north and south revealed that this monument was out of position, being 30.96 farther north. A searched was made for the original stone and bearing trees and no evidence was found. There are many stones of call size in the vicinity, but none were found with markings or planted in the ground. There were no tamarack trees found in the vicinity and the area is predominately covered by fir trees. The area appears to have been disturbed by logging activity.
