RECORD OF LAND CORNER MONUMENTATION

SOUTH 1/4 CORNER SECTION 30, T. 8 S., R. 37 E., W.M.

FILED December 20, 2023
 BAKER COUNTY SURVEYOR
 SURVEY NO. 8-37-157

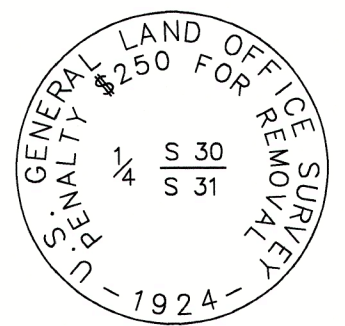
CORNER MONUMENT
MARKED:

EVIDENCE FOUND: Found 1" iron pipe with 2 1/2" brass cap, marked as shown below, laying downhill, with only 6" of pipe still in the ground. The monument appears to have been disturbed when Hanley's lodgepole bearing tree fell over and was uprooted. Also found Hanley's steel fence post bent and alongside. Corner is located on a steep slope.
 From which:
 ► A dead and down (wind thrown) lodgepole pine bears S.33°E., 6 ft. (approx. center of rootwad depression)(Hanley BT)
 ► A white fir, 25" dbh, bears S.08 1/4°E., 145.2 ft., with visible scribing in a partially healed blaze (GLO BT)
 I did not search for the other GLO bearing tree, as it is approximately 450 feet away and is of little value as an accessory.

DESCRIPTION OF MONUMENTS AND ACCESSORIES SET AND METHODS USED:
 I accept the position of the spin point of the found monument for the corner. I reset the iron pipe with brass cap 30" in the ground. I stabilized the monument and the bank below it by building a rock wall, 4 ft. base, 4 ft. tall to the top.
