RECORD OF LAND CORNER MONUMENTATION

CORNER: SOUTHEAST COR. SECTION 35, TWP. 8 S., RANGE 40 E., W.M.

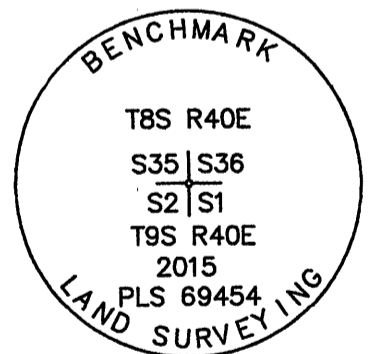
At the corner point, I set a 5/8"x24" iron pin with attached 2" aluminum cap 30" in the ground. Top of cap is 6" below the asphalt road surface. Cap is marked as shown below. I left the unrecorded 1/2" pin in place.
