Alpha-Num.  
Index # J-11

**CERTIFIED RECORD OF LAND CORNER MONUMENTATION**

FILED December 31, 2001  
BAKER COUNTY SURVEYOR  
SURVEY NO. 9-40-543  
CORNER PRES. NO. CP #77

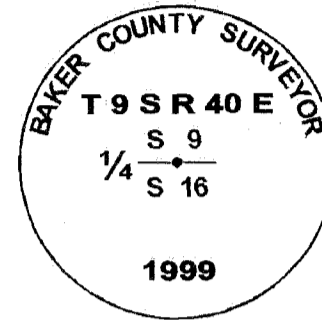
**DIAGRAM**

Found a 1/2" rebar with yellow plastic cap. Rebar was badly bent. It is assumed that Baker County Survey No. 9-40-25BC was in error by stating this as being a 5/8" rebar.

The corner was reestablished at the position of the base of the 1/2" rebar. Set a 2 1/2" diameter brass cap on a 1" x 30" galvanized pipe, guarded by a steel fence post. The cap is marked as shown in the corner diagram.
