RECORD OF LAND CORNER MONUMENTATION

CORNER: SOUTHEAST COR. SECTION 35, TWP. 8 S., RANGE 40 E., W.M.

FILED January 22, 2016
BAKER COUNTY SURVEYOR
SURVEY NO. 8-40-410
9-40-745

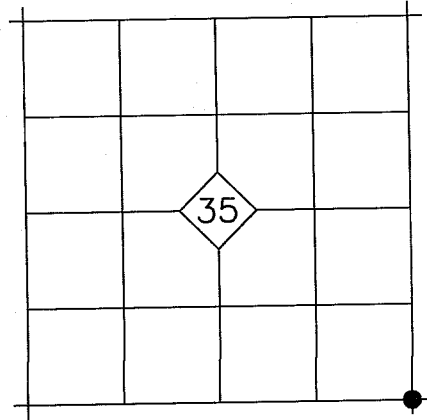
EVIDENCE FOUND: I found the east reference monument, which is a 5/8" rebar with no cap in the east right of way fence. I also found the west reference monument, also a 5/8" rebar with no cap, which was badly bent and out of position. Although the origin of these monuments is unknown, they have been utilized as references to the section corner on Survey No.'s 9-40-13, 9-40-25 and 9-40-558. I reestablished the section corner at the record bearing and distance of S.89°16'05"W., 28.91 feet from the east reference monument. I also found an unrecorded 1/2" iron pin with yellow cap (illegible markings) 0.14' North and 0.20' East, which is not accepted. The top of this pin is 1 foot below the asphalt surface.
