OREGON CORNER RESTORATION FORM

Range 98 45E Section Township August 30, 2001 County Date: Baker Condition Report Only 9S45P17 Not found Corner Designation: Remonumented Common quarter corner to sections 22 and 23, T9S, R45E, Unrecorded W.M., Baker County, Oregon. Surveyed in Referenced out

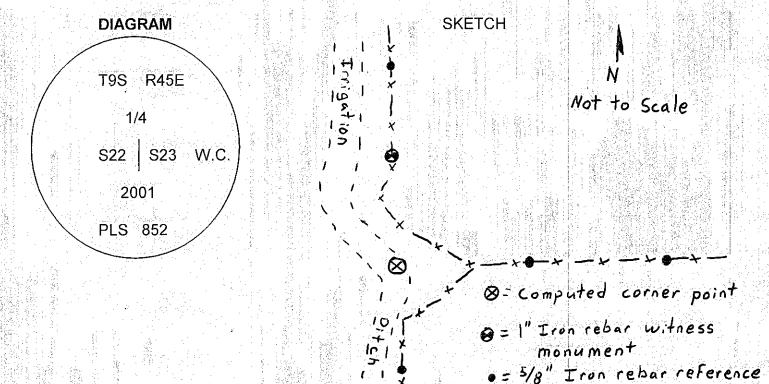
Monument and Accessories found: (condition and source)
Portions of fence lines running North, South, and East. The actual corner point falls in the irrigation canal.

MONUMENT (S) AND ACCESSORIES SET (Procedures and Description)
Set a 1" x 24" iron rebar with a 2" Aluminum cap stamped as shown in the diagram above at the projected intersection of the fences. This position was verified by distances to corners as seen on County Survey 9-45-37.

For references, I set four 5/8" by 24" rebars with 1.25" red plastic caps stamped ORLS 852 and WALS 13922 as described below:

an iron rebar bears N02°17'53"E, 160.64 feet, under the existing fence; an iron rebar bears S87°26'58"E, 106.24 feet, under the existing fence; an iron rebar bears S87°44'48"E, 167.36 feet, under the existing fence; an iron rebar bears S00°05'57"W, 114.89 feet, under the existing fence;
