CERTIFIED RECORD OF LAND CORNER MONUMENTATION

K-17

FILED 7-21-86
DANER COUNTY SURVEYOR
SURVEY NO 10-35½-182

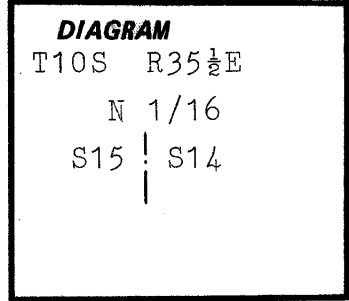
Found down monument by Myers. Reset corner position by survey. Based on location poster and scattered rock mound, Myers monument was located very close to corner position by this survey.

Set a 2½" by 30" aluminum pipe with 2½" aluminum cap 10" in the ground to bedrock and surrounded with a mound of earth and stone. Placed Myers monument inside our new monument. From the new monument:
