CERTIFIED RECORD OF LAND CORNER MONUMENTATION

FILED June 28, 2011
BAKER COUNTY SURVEYOR
SURVEY NO. 12-41-10

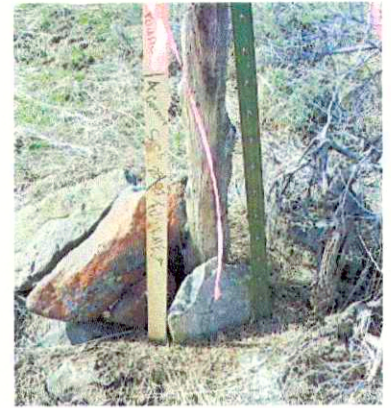
At this 1/4 corner location, I found a Sandstone 36" x 14" x 4" broken in half. The top half is loosely set about 6 inches in the ground, the bottom half still firmly set deep in the ground, with a large mound of stone directly to the West of the corner point. I noted this stone had been tampered with, as the stone had been turned around before resetting. The stone is clearly marked, as shown in the accompanying photo, with 1/4 28, now facing to the East, and the marking 27 on the opposite side and facing to the west. I also found a Juniper post driven alongside the stone and nearly rotted off at the base as well as a steel fencepost driven alongside. The position of this corner appears to agree with the original GLO survey notes, thus I accepted its position.

1/4 corner stone and accessories as found in place.

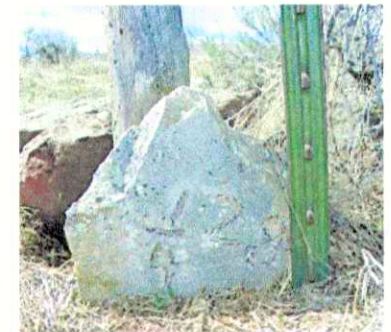
Note the markings 1/4 28 are clearly visible.

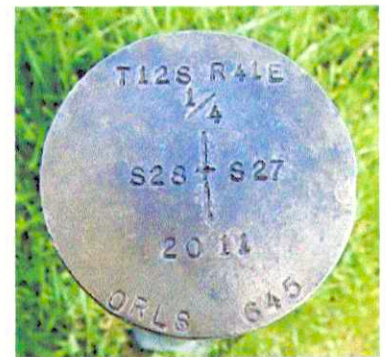
Brass cap as stamped.

At the exact location of the cornerstone, I placed a 2 1/2 inch brass monument affixed to the top of a 1" x 30" flared galvanized pipe. The brass cap is about 6 inches above the surface of the ground and stamped as shown in the accompanying photo. I placed the original stone upside down and buried along the west face of the monument, with a raised mound of stones around the monument flush with the top of the cap. I did not disturb the mound of stone found to the west of the monument, leaving it in its original position. No bearing trees were accessible. Therefore I set four bearing objects, being 5/8" x 30" iron rebar with a orange plastic cap affixed to the top, marked Reference Monument, driven to within 6 inches above the surface of the ground, located as follows:
