RECORD OF LAND CORNER MONUMENTATION

SOUTH 1/4 CORNER SECTION 30, T. 8 S., R. 37 E., W.M.

FILED December 20, 2023
 BAKER COUNTY SURVEYOR
 SURVEY NO. 8-37-157

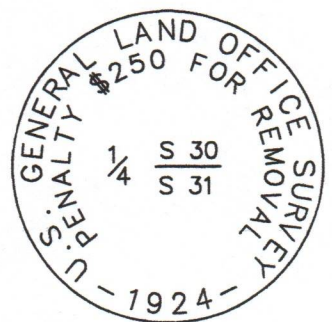
CORNER MONUMENT
MARKED:

EVIDENCE FOUND: Found 1" iron pipe with 2 1/2" brass cap, marked as shown below, laying downhill, with only 6" of pipe still in the ground. The monument appears to have been disturbed when Hanley's lodgepole bearing tree fell over and was uprooted. Also found Hanley's steel fence post bent and alongside. Corner is located on a steep slope.
 From which:
 ▶ A dead and down (wind thrown) lodgepole pine bears S.33°E., 6 ft. (approx. center of rootwad depression)(Hanley BT)
 ▶ A white fir, 25" dbh, bears S.08 1/4°E., 145.2 ft., with visible scribing in a partially healed blaze (GLO BT)
 I did not search for the other GLO bearing tree, as it is approximately 450 feet away and is of little value as an accessory.

DESCRIPTION OF MONUMENTS AND ACCESSORIES SET AND METHODS USED:
 I accept the position of the spin point of the found monument for the corner. I reset the iron pipe with brass cap 30" in the ground. I stabilized the monument and the bank below it by building a rock wall, 4 ft. base, 4 ft. tall to the top.
