**CERTIFIED RECORD OF LAND CORNER MONUMENTATION**

Corner 1, Annululu Lode, also Corner 1, Chapman Lode, M.S. 382 A, also Corner 4, Boulder Lode, M.S. 447.

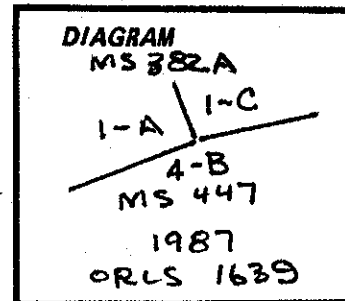
A lodgepole pine snag 12" dia with partially healed blaze brs N49°W, 17.5' dist (record, N53°W 18.0') scribed ANNULULU MS 382 Cor 1 BT.  
A sawed wind blow snag 9" dia with opened blaze scribed CHAPMAN MS 382 Cor 1 (position of root hole indefinite). These are original BTs.  
JRM BTs: A white fir 7" dia brs N5°W, 10.8' dist mkd CH 1 MS 382A BT on partially healed blaze.  
A white fir 8" dia brs N61°W, 8.0' dist mkd CH 1 MS 382A BT on partially healed blaze.  
A 2½" brass cap on 1" galvanized iron pipe in earth and rock mound marked as shown beside:

Removed brass cap monument & replaced with 2" x 30" aluminum pipe with 2½" aluminum cap 20" in ground surrounded with a mound of earth and stone. Set 6' steel fence post alongside with signs 54-2 & 54-9. Corner marked as shown in corner diagram.  
Painted 6" band of red around each OBT and JRM-BT.
