CERTIFIED RECORD OF LAND CORNER MONUMENTATION

FILED May 20, 2013
BAKER COUNTY SURVEYOR
SURVEY NO. 9-40-712
9-41-18

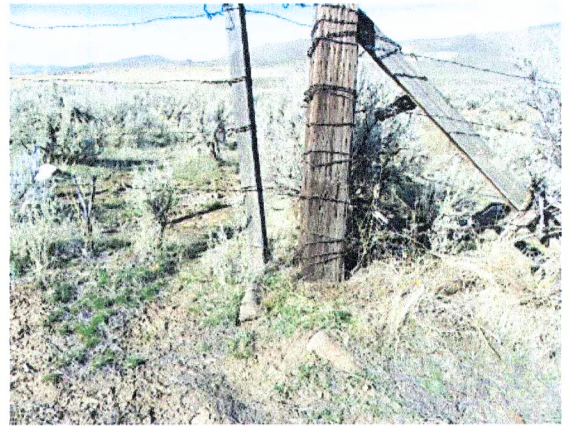
Notice the historic fence corner with a straight fence line running over a mile to the North over the distant horizon. It appears this corner was used possibly even to control the property of early homesteaders.

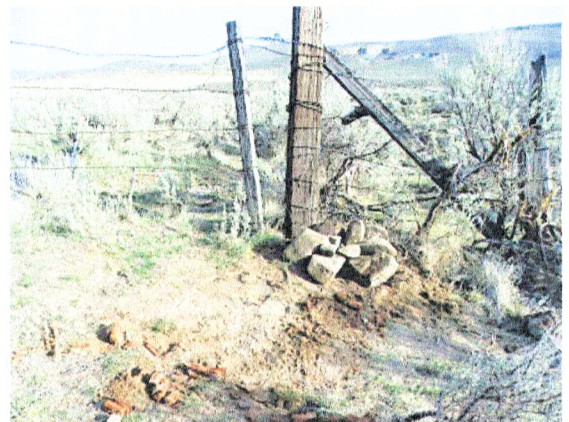
Notice the rotted remains of the original fence post I found buried deep in the ground and where I set the Brass Cap monument. The stone mound is as it appeared before I buried it with soil to help stabilize the stones for the future.

To perpetuate this Section Corner at the location of the original badly rotted post, I set a 2 1/2 inch Brass Cap on a 1" x 30" galvanized iron pipe. I buried the pipe to within 8 inches above the ground surface. I then placed a mound of stone and soil three feet in diameter about the monument covering the brass cap. The brass cap monument is stamped as shown in the accompanying photo.

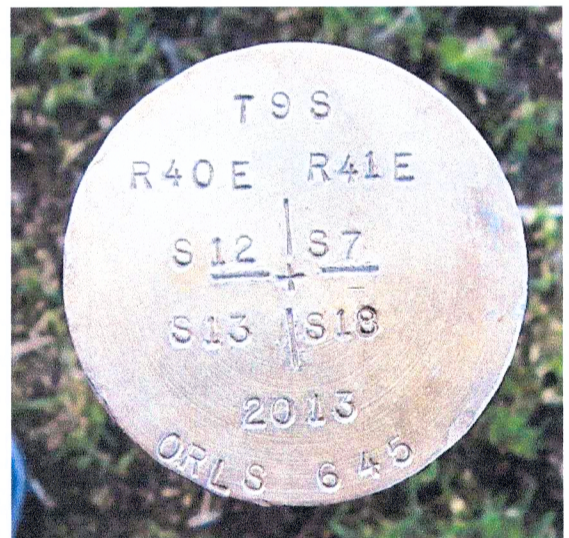
Brass Cap as stamped.
