CERTIFIED RECORD OF LAND CORNER MONUMENTATION

T. 9 S., R. 41 E.

J - 1

FILED January 29, 2025
BAKER COUNTY SURVEYOR
SURVEY NO. 9-40-876
9-41-41

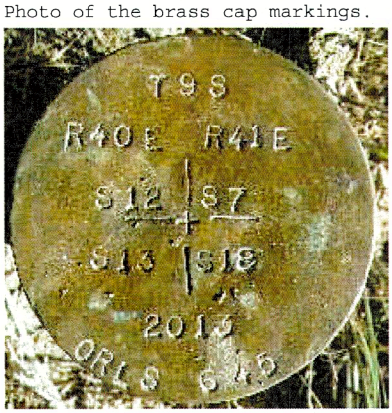
Description: The cor. of secs. 7, 12, 13 and 18, T. 9 S., Rs. 40 and 41 E., monumented with a galvanized iron pipe, 1 in. diam., firmly set, projecting 3 ins. above a mound of stone, 2 ft. base, 1/2 ft. high, with brass cap mkd. with brass cap mkd. as shown below on this corner record and on Mr. Hambleton's recorded Land Corner Monumentation Form.

Photo of the brass cap markings.

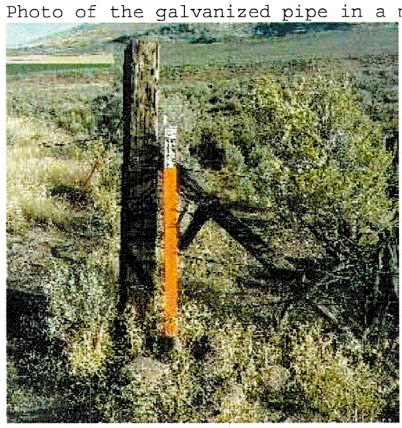
Corner is in the corner of barbed wire fences, from which barbed wire fences extend N., E., and W.

Set a carsonite post N. of the galvanized iron pipe and on the edge of the mound of stone, approximately 1 ft. dist.

Photo of the galvanized pipe in a mound of stone.
