CERTIFIED RECORD OF LAND CORNER MONUMENTATION

Corner established by W.B. Barr under GLO Contract No. 443 dated May 29, 1882.

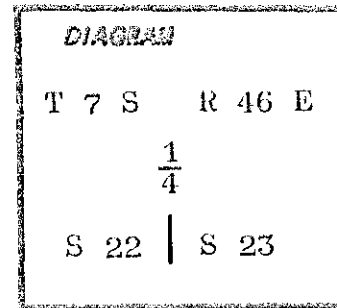
Set post 4 ft long 4 ins diam 24 ins in ground for 1/4 Sec corner marked 1/4 S on the West side, from which:

A pine 48 ins diam bears N 14° E 74 lks dist mkd 1/4 S BT  
A pine 16 ins diam bears N 76° W 60 lks dist mkd 1/4 S BT

A pine 38 ins diam with partially opened blaze for section 22 BT bears N 76° W, 39.6 ft (60 lks) - This tree has been burned and no visible scribing remains. The upper portion of the blaze shows signs of healed blaze.

Set a 2½ inch brass cap on a 2 inch iron pipe 31 ins long 27 ins in the ground with a 6 ft steel fence post alongside with a sign 54-4 and 2 signs 54-2 attached.

A pine 06 ins diam bears S 88° E, 33.5 ft dist mkd 1/4 S 23 BT  
A pine 12 ins diam bears N 55° W, 86.8 ft dist mkd 1/4 S 22 BT
