BENCHMARK LAND SURVEYING
217 N. CANYON BLVD., JOHN DAY, OREGON
2101 MAIN STREET, STE 223 BAKER CITY, OREGON
541-575-1251 - 800-699-0516

DOGAMI SURVEY
DOGAMI ID NO. 01-0063
A DEPENDENT RESURVEY AND SUBDIVISION OF SECTIONS
34 AND 35, T.8S., R.40E., W.M.,
BAKER COUNTY, OREGON

SURVEYED FOR	NORTHWEST LAND RESOURCES, LLC
SURVEYED BY	JLH, MCS & MRT
DATE	12/29/2015
SCALE: 1"=500'	DRAWN BY: JLH

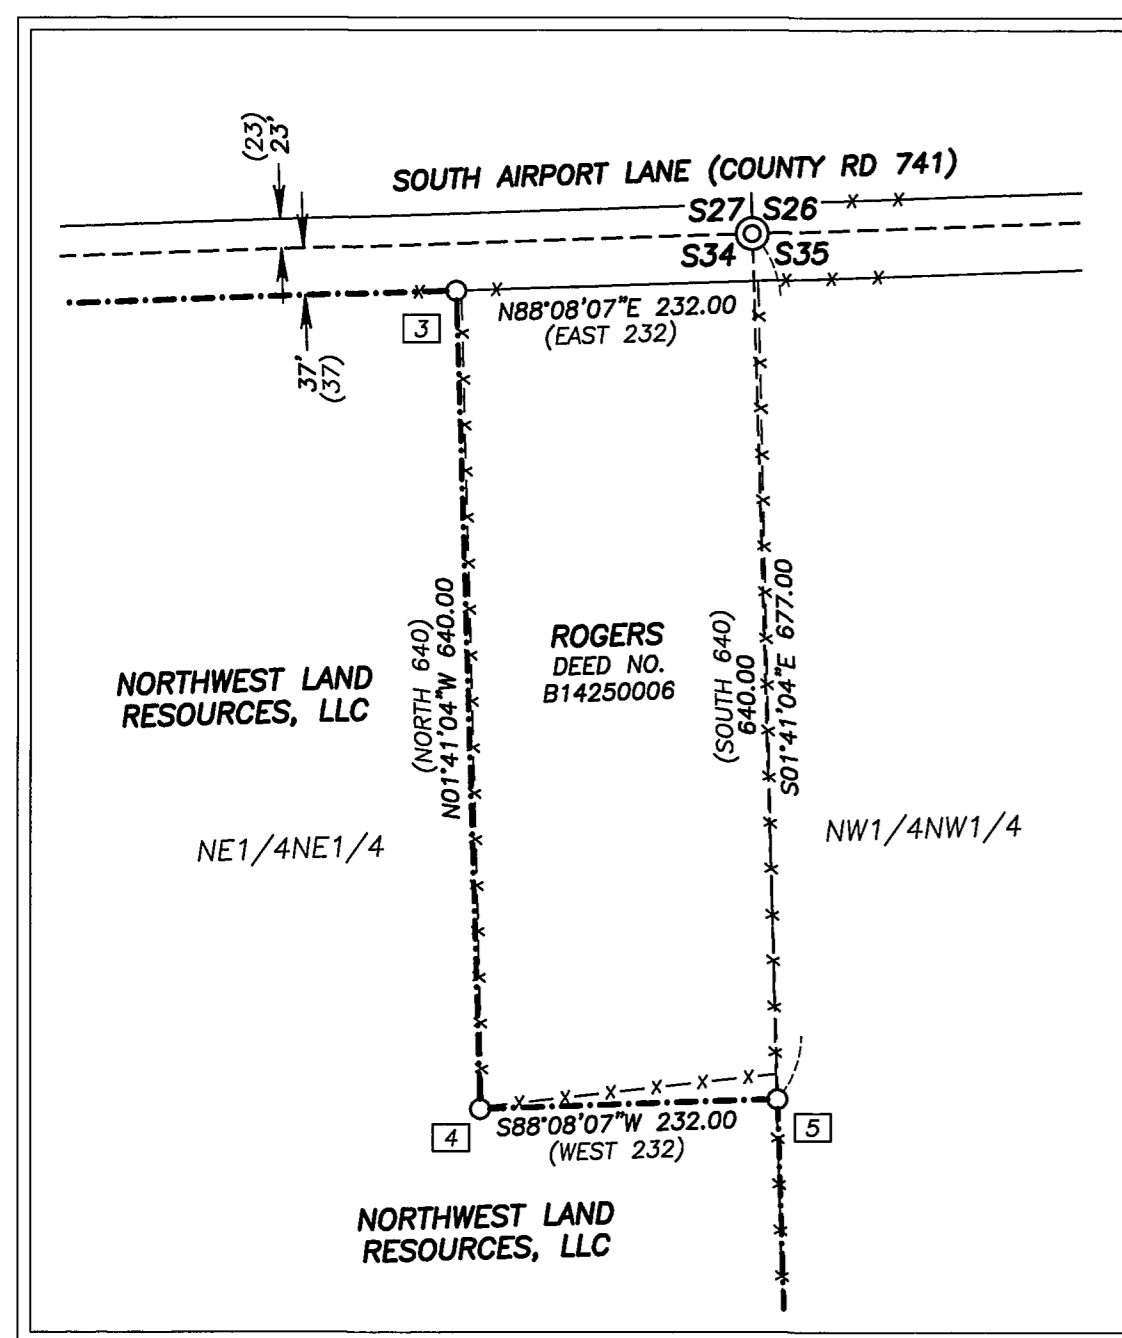
DETAIL

NOT TO SCALE

A SEARCH OF THE DEED RECORDS REVEALED THAT IN 1963 BAKER COUNTY ACQUIRED PROPERTY FOR THE RIGHT OF WAY OF SOUTH AIRPORT LANE (COUNTY ROAD NO. 741). I FOUND THAT THE 60 FOOT WIDE RIGHT OF WAY IS NOT CENTERED ON THE SECTION LINE, AS IS THE COMMON SITUATION. IN THE CASE OF SOUTH AIRPORT LANE, LANDOWNERS TO THE SOUTH CONVEYED THE NORTH 37 FEET OF THEIR PROPERTY AND LANDOWNERS TO THE NORTH CONVEYED THE SOUTH 23 FEET OF THEIR PROPERTY. IN 1983, JIM HANLEY, PLS., PERFORMED SURVEY NO. 8-40-6, WHERE HE DETERMINED THE LOCATIONS OF THE CONTROLLING CORNERS OF SECTION 34. THE ORIGINAL MONUMENTS AT THE NORTH QUARTER CORNER AND NORTHEAST CORNER OF SECTION 34 WERE OBLITERATED BY THE ROAD, AS RURAL COUNTY ROADS ARE TYPICALLY CENTERED ON SECTION LINES. THE RIGHT WAY FENCES ARE OFTEN THE BEST AVAILABLE EVIDENCE OF THE LOCATION OF THE SECTION LINES AND CORNERS. AS SUCH, MR. HANLEY REESTABLISHED THESE CORNERS MIDWAY BETWEEN RIGHT OF WAY FENCES, WHICH IS A COMMONLY ACCEPTED PRACTICE. HOWEVER, IN THIS CASE IT SEEMS THE 1983 RIGHT OF WAY DEEDS MAY HAVE BEEN OVERLOOKED. THESE DEEDS ARE A CRITICAL PIECE OF EVIDENCE IN DETERMINING THE LOCATION OF THIS SECTION LINE. I BELIEVE THAT IF MR. HANLEY WOULD HAVE HAD KNOWLEDGE OF THESE RIGHT OF WAY DEEDS, HE WOULD HAVE REESTABLISHED THE CORNERS ACCORDINGLY. THIS PROBLEM SEEMS TO BE ISOLATED TO THE NORTH HALF OF SECTION 34, SINCE THE EAST-WEST CENTER LINE OF SECTION 34 IS BASED ON FOUND EVIDENCE AT THE EAST AND WEST QUARTER CORNERS, AND WILL NOT CHANGE. BAKER COUNTY SURVEY NO. 8-40-10, PERFORMED BY JIM HANLEY IN 1985 IS THE ONLY SUBSEQUENT SURVEY OF RECORD THAT I FOUND IN WHICH CORNER POSITIONS WILL BE AFFECTED. I HAVE DISCUSSED MY FINDINGS WITH TOM HANLEY OF HANLEY ENGINEERING AND CURRENT BAKER COUNTY SURVEYOR. THE MONUMENTS FROM SURVEY NO. 8-40-6 AT THESE TWO LOCATIONS ARE LEFT IN PLACE, BUT HAVE BECOME REFERENCES TO THE NORTH QUARTER CORNER AND NORTHEAST CORNER OF SECTION 34. NEW MONUMENTS WERE SET AT BOTH CORNERS TO ACCOUNT FOR THE 7 FOOT DIFFERENCE, AS SHOWN.

WE MADE FIELD MEASUREMENTS TO SEARCH FOR MONUMENTS SET DURING SURVEY NO. 8-40-10, BUT FOUND ONLY TWO REMAINING. ONE WAS FOUND AND ACCEPTED AT THE RIGHT OF WAY INTERSECTION OF SOUTH AIRPORT LANE AND LINDLEY ROAD. DUE TO THE 7 FOOT DIFFERENCE IN THE NORTH LINE OF THE NE1/4 SECTION 34 AS DISCUSSED PREVIOUSLY, THE OTHER MONUMENT WAS FOUND SOUTH 3.5 FEET FROM THE CORNER, AND IS NOT ACCEPTED. WE ALSO SEARCHED FOR THE MONUMENT SET DURING SURVEY NO. 8-40-6 AT THE CENTER-NORTH 1/16 CORNER BUT FOUND NO TRACE OF IT. I ACCEPT THE FOUND MONUMENTS OF RECORD AT THE EAST QUARTER CORNER, SOUTHWEST CORNER, THE SOUTH QUARTER CORNER AND THE WEST QUARTER CORNER SECTION 34. THE FOLLOWING CONTROLLING CORNERS OF SECTION 35 WERE REESTABLISHED ACCORDING TO THE EVIDENCE FOUND:
