RECORD OF LAND CORNER MONUMENTATION

CORNER: SOUTHWEST COR. SECTION 4, TWP. 8 S., RANGE 40 E., W.M.

FILED May 20, 2020
BAKER COUNTY SURVEYOR
SURVEY NO. 8-40-45

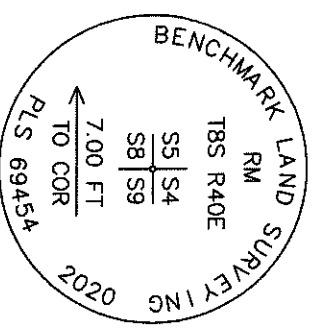
The corner position falls in an irrigation ditch where a permanent monument would be liable to destruction. Therefore, I set a reference monument S.89°30'00"E., 7.00 feet from the true corner. The reference monument is a 1½"x30" galvanized iron pipe with attached 2½" brass cap set 28" in the ground. Cap is marked as shown below.
