**SURVEY NARRATIVE**

MAP OF SURVEY  
 FOR CORNER REESTABLISHMENT  
 IN SECTIONS 10, 11, 14 & 15, T. 9 S., R. 40 E., W.M.  
 Surveyed March 13 to April 2, 1980      Scale 1'=1000'  
 FOR JOHN BOOTSMA

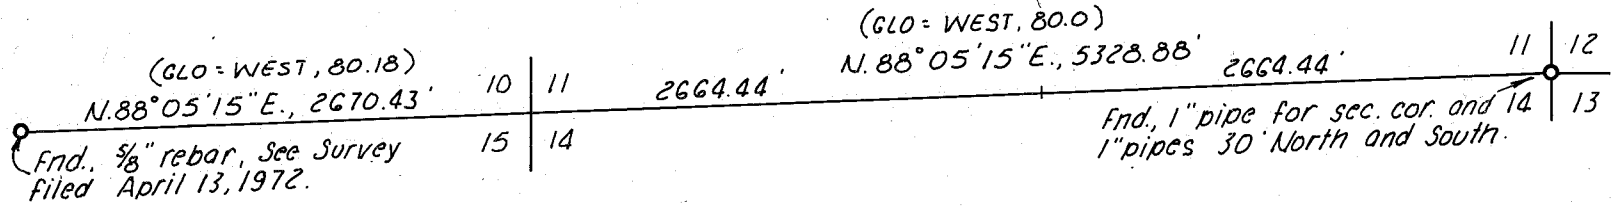
Meridian based on City Survey  
 of 1970 filed Jan. 17, 1971.

The South quarter corner of Section 10, marked by a 5/8 inch rebar and the corner common to Sections 11, 12, 13 and 14, T. 9 S., R. 40 E., W.M., marked by an iron pipe, which in turn is referenced by iron pipes 30 feet North and 30 feet South were found in place. An East-West running county road has been constructed over the South quarter corner of Section 11 and the corner common to Sections 10, 11, 14 and 15.

These two obliterated corners were reestablished by East-West proportionate measurements between the two found corners for their East coordinates. The North coordinate for the missing section corner was determined by using the centerline of the existing county roadway, since the road had been constructed along the section lines.

The line between Sections 10 and 15 is a continuation of the line between Sections 11 and 14, using the above method of reestablishment. I believe the above results in the most likely positioning of the original corner locations. A North-South proportionate measurement would not result in centering the county road, and was rejected for that reason. No permanent monuments were established during the course of this survey.
