MAP OF SURVEY

A PROPERTY LINE ADJUSTMENT SITUATED IN THE NW1/4 OF SECTION 22, T9S, R45E, WM, BAKER COUNTY, OREGON

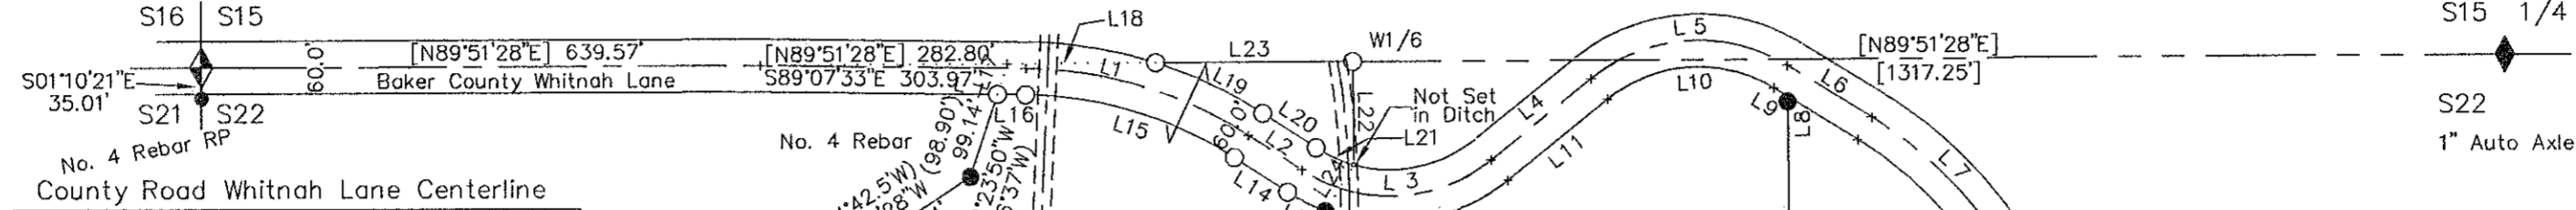
Reference Points
 Power Pole S43°10'E, 49.79'
 Angle Point in concrete wall N40°35'E, 29.50'
 Gate Post N57°13'W, 39.16'
 No. 4 Rebar S1°10'21"E, 35.01'

4" under road surface
 Set 30" x No. 5 Rebar with Yellow Plastic Cap marked "PLS 699"
