AUBURN CREEK RANCH BOUNDARY SURVEY A Portion of Sections 11, 12, 13, 14, 15, 22, 23, 24 & 25, T 12 S, R 40 E W. M.

BAKER COUNTY OREGON

Date July 24, 2013

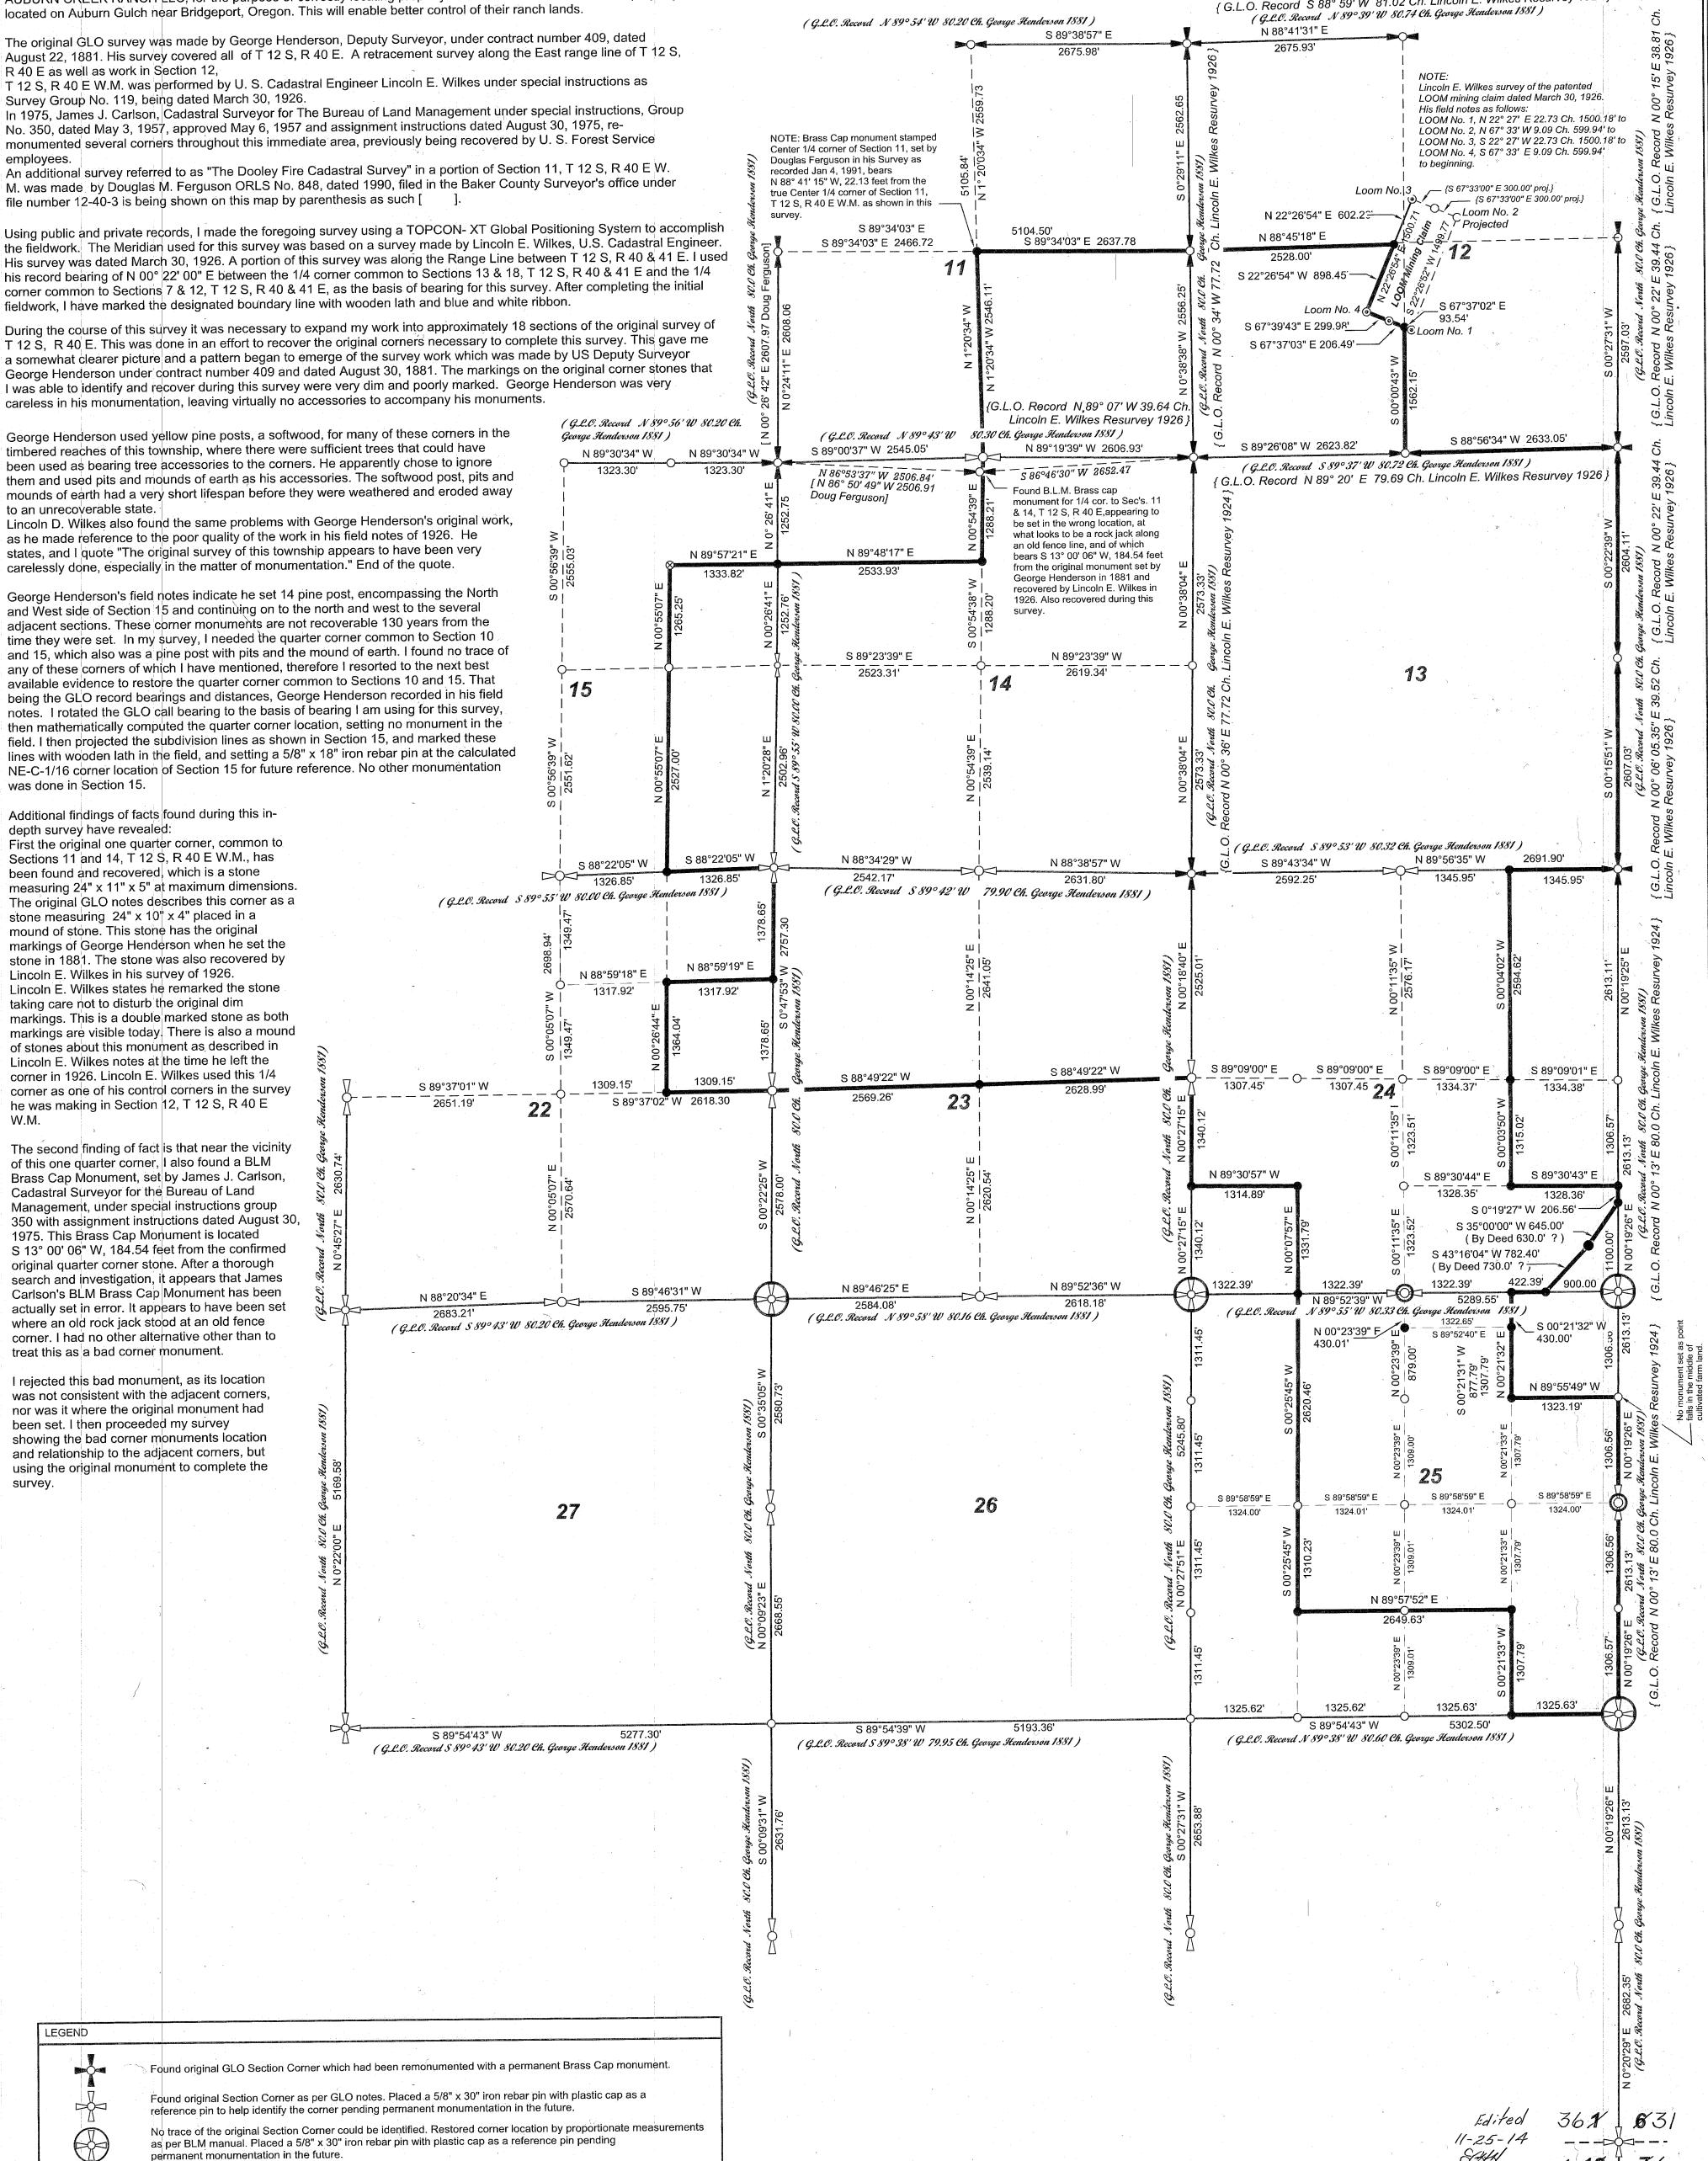
Scale 1 Inch = 1000 Feet

Additional findings of facts found during this indepth survey have revealed: First the original one quarter corner, common to Sections 11 and 14, T 12 S, R 40 E W.M., has been found and recovered, which is a stone measuring 24" x 11" x 5" at maximum dimensions. The original GLO notes describes this corner as a stone measuring 24" x 10" x 4" placed in a mound of stone. This stone has the original markings of George Henderson when he set the stone in 1881. The stone was also recovered by Lincoln E. Wilkes in his survey of 1926. Lincoln E. Wilkes states he remarked the stone taking care not to disturb the original dim markings. This is a double marked stone as both markings are visible today. There is also a mound of stones about this monument as described in Lincoln E. Wilkes notes at the time he left the corner in 1926. Lincoln E. Wilkes used this 1/4 corner as one of his control corners in the survey he was making in Section 12, T 12 S, R 40 E W.M.

The second finding of fact is that near the vicinity of this one quarter corner, I also found a BLM Brass Cap Monument, set by James J. Carlson, Cadastral Surveyor for the Bureau of Land Management, under special instructions group 350 with assignment instructions dated August 30, 1975. This Brass Cap Monument is located S 13° 00' 06" W, 184.54 feet from the confirmed original quarter corner stone. After a thorough search and investigation, it appears that James Carlson's BLM Brass Cap Monument has been actually set in error. It appears to have been set where an old rock jack stood at an old fence corner. I had no other alternative other than to treat this as a bad corner monument.

I rejected this bad monument, as its location was not consistent with the adjacent corners, nor was it where the original monument had been set. I then proceeded my survey showing the bad corner monuments location and relationship to the adjacent corners, but using the original monument to complete the survey.
