REFERENCE MATERIAL

Survey Number 12-40-13

NARRATIVE

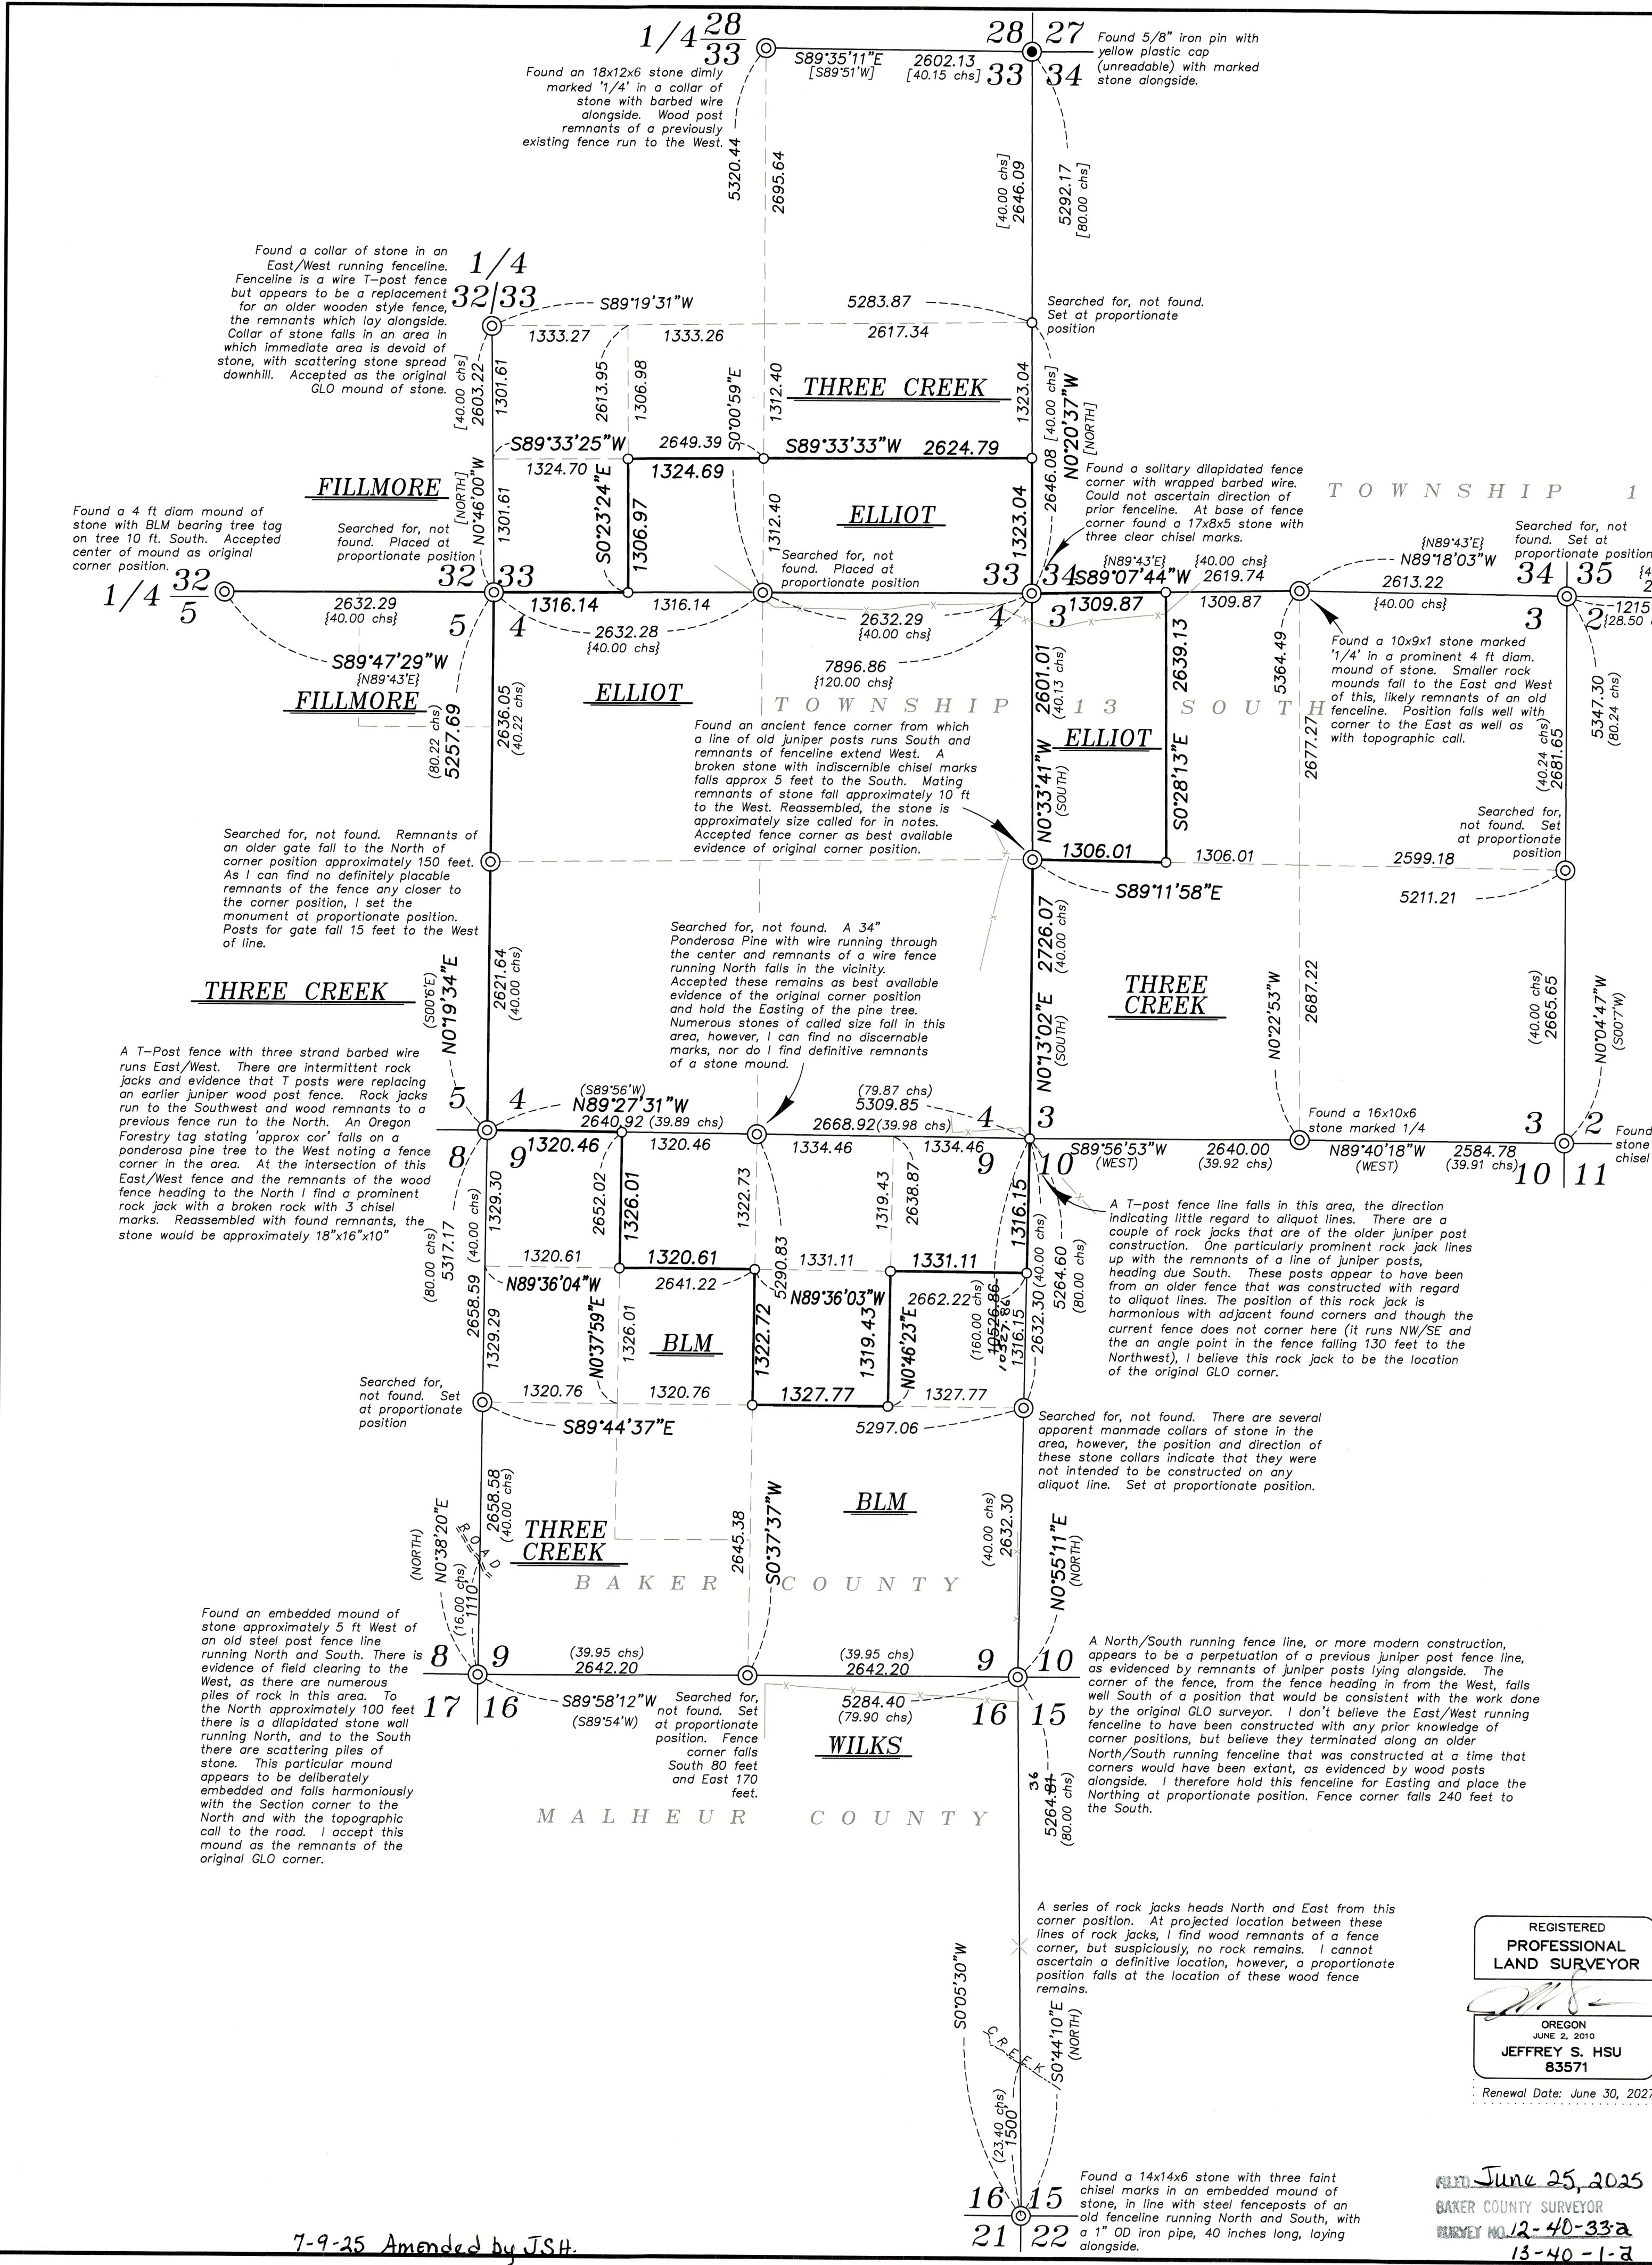
This survey was done at the request of Sam Martin, manager of lands owned by Three Creek Ranch. Mr. Martin wanted select corners set prior to fencing. Township 13 South, Range 40 East was originally surveyed by GLO surveyor John Kincaid. No subsequent records or retracements within this Township were found within the County Surveyor records of Baker or Malheur counties. In my retracement of Kincaid, I find there to be numerous inconsistencies with regard to stone sizes, chisel marks, and topographic calls. Found stone corners which bear clear definitive chisel marks are grossly undersized. And stones of called size generally bear faint, incomplete, or nonexistent marks. Due to the fact that in some of the locations of the undersized stones, that there would be very little reason to choose a stone of such size, I can only ascertain that the undersized stones were chiseled in the comforts of camp and transported to the location that they were ultimately set, while corners set from stones found in the immediate area were more poorly marked, if marked at all.

There are numerous fences around this area that do not seem to make any attempt to follow title lines. However, there are remnants of much older fences that preexisted in this area, constructed with natural juniper wood posts, that do appear to have been constructed with regard to aliquot corners. Though these remnants are from an era that current landowners appear to be unaware of their history or even their presence, due to the harmony of these fence remnants with record measurements as per the GLO record, I presume that many of the original GLO corners were known at the time of this fence construction. Some of these fencelines can be seen in a 1953 aerial photo, however, some of these fences may even predate even that generation, as the location of some of the fencelines (where scattering remnants still remain today) are not apparent in this photo. I therefore place heavy reliance on these old fencelines (and modern fences that appear to perpetuate the older fence) as representing the best available evidence of the original corner positions.

The subdivision of Township 12 South, Range 40 East was surveyed by GLO Surveyor George Henderson. It is notable that Henderson also found Kincaid's stones to be of a smaller size than called for in his notes.

Subdivision of sections is done as per BLM Manual of Instruction 2009. I find no other unusual conditions with this survey.

- T12S40E (V-11) - Found an 18x12x6 inch stone marked '1/4'. This stone falls in a collar of stone with barbed wire and was likely an old fence corner. From this point a series of old wooden posts extends to the West, with scattering barbed wire alongside. This fence is of a vintage that current landowners were seemingly unaware of its presence.

- T12S40E (X-09) - A fenceline runs East/West in this area. Fence is a three stand barbed wire fence of T-post construction. Older wooden fenceposts lie on either side of the fence, and the T-post fence appears to be a replacement of this older wooden fence. I find a collar of stone with scattering stones laying downhill (North). There is a rock outcrop several hundred feet to the Northeast as well as a smaller outcrop to the West, however within the immediate vicinity of this collar, there do not appear to be many stones on the uphill or sidehill sides. I believe this to be remnants of the original stone mound and accept it as the best available evidence of the original corner position.

- T13S40E (A-19) - At this location, I find a stone of called size, marked '1/4'. This stone is face down on a steep hillside falling approximately 6 feet from the creek. The topographic calls in this area lead me to believe that there may have been some transcription errors between the field notes taken in the field and the final field notes submitted to the GLO. The spring branch, indicated as being 28.50 chains on line, falls close to a 18.50 chains. The topographic call to the creek East of this quarter corner is noted as being 42.50 chains on line. I find that a position 2.50 chains to be grossly discordant with his other corner location on the township line and I believe a scrivener error also was made on this call. It is highly likely that the call was intended to be 40.25 chains rather than 42.50 chains. I measure a point from the creek, uphill through the found stone, 0.25 chains and find that there are scattering stones falling on the downhill side of this point, but no stones in the immediate area uphill from this point. I believe these stones to be remnants of the original stone mound, and hold this point as the location of the original corner position.

- T13S40E (C-13) - At this position, I find a dilapidated fence corner with a row of juniper fence posts heading South, with wire alongside. The posts terminate at a point where a broken stone with clear chisel marks falls 5 ft. South. This stone is broken, and remnants falls approximately 10 feet to the West. Collectively, they make up a stone of called size. Chisel marks are clear, however, I cannot make out a clear '1/4'. There are scattering bits of barbed wire heading to the West where it meets with a prominent rock jack that comprise the modern day fence, approximately 230 feet West of the fence corner. I accept this fence corner at the Northern terminus of this line of juniper fence posts as the original corner position.

- T13S40E (E-09) - A wire fence runs East and West through this corner position, with juniper posts lying alongside, and some juniper posts still erect in the fence. There is evidence of two fence corners in this area, one that heads North, evidenced by old wood posts, and one that heads to the Southwest, evidenced by old rock jacks, through they terminate at different locations. The fence heading in from the North terminates at a prominent rock mound, where I find an undersized stone with three chisel marks lying loosely amongst the stones. This stone appears to have been broken and reassembled with other fragments, the stone appears to have been 18"x16"x10". Despite having the incorrect number of marks, I accept the location of this rock jack as the original corner position.

- T13S40E (J-13) - There exists a fence corner in this area, from which fences bears North and West. The fence running North/South show evidence of older wooden fence posts, indicating it likely replaced a former fence. The corner of this fence falls grossly out of position from record measurements as per the GLO field notes, and I believe the portion of this fence running West was done without knowledge of the original GLO corner, and was likely built only as a fenceline of convenience, terminating on the East side at the older wooden fence, which I believe was built with regard to the original GLO corner monuments. I therefore hold the Easting of the fenceline and use a proportionate position for the Northing.
