MEYEY NO. 12 - 40-33

REFERENCE MATERIAL

NARRATIVE

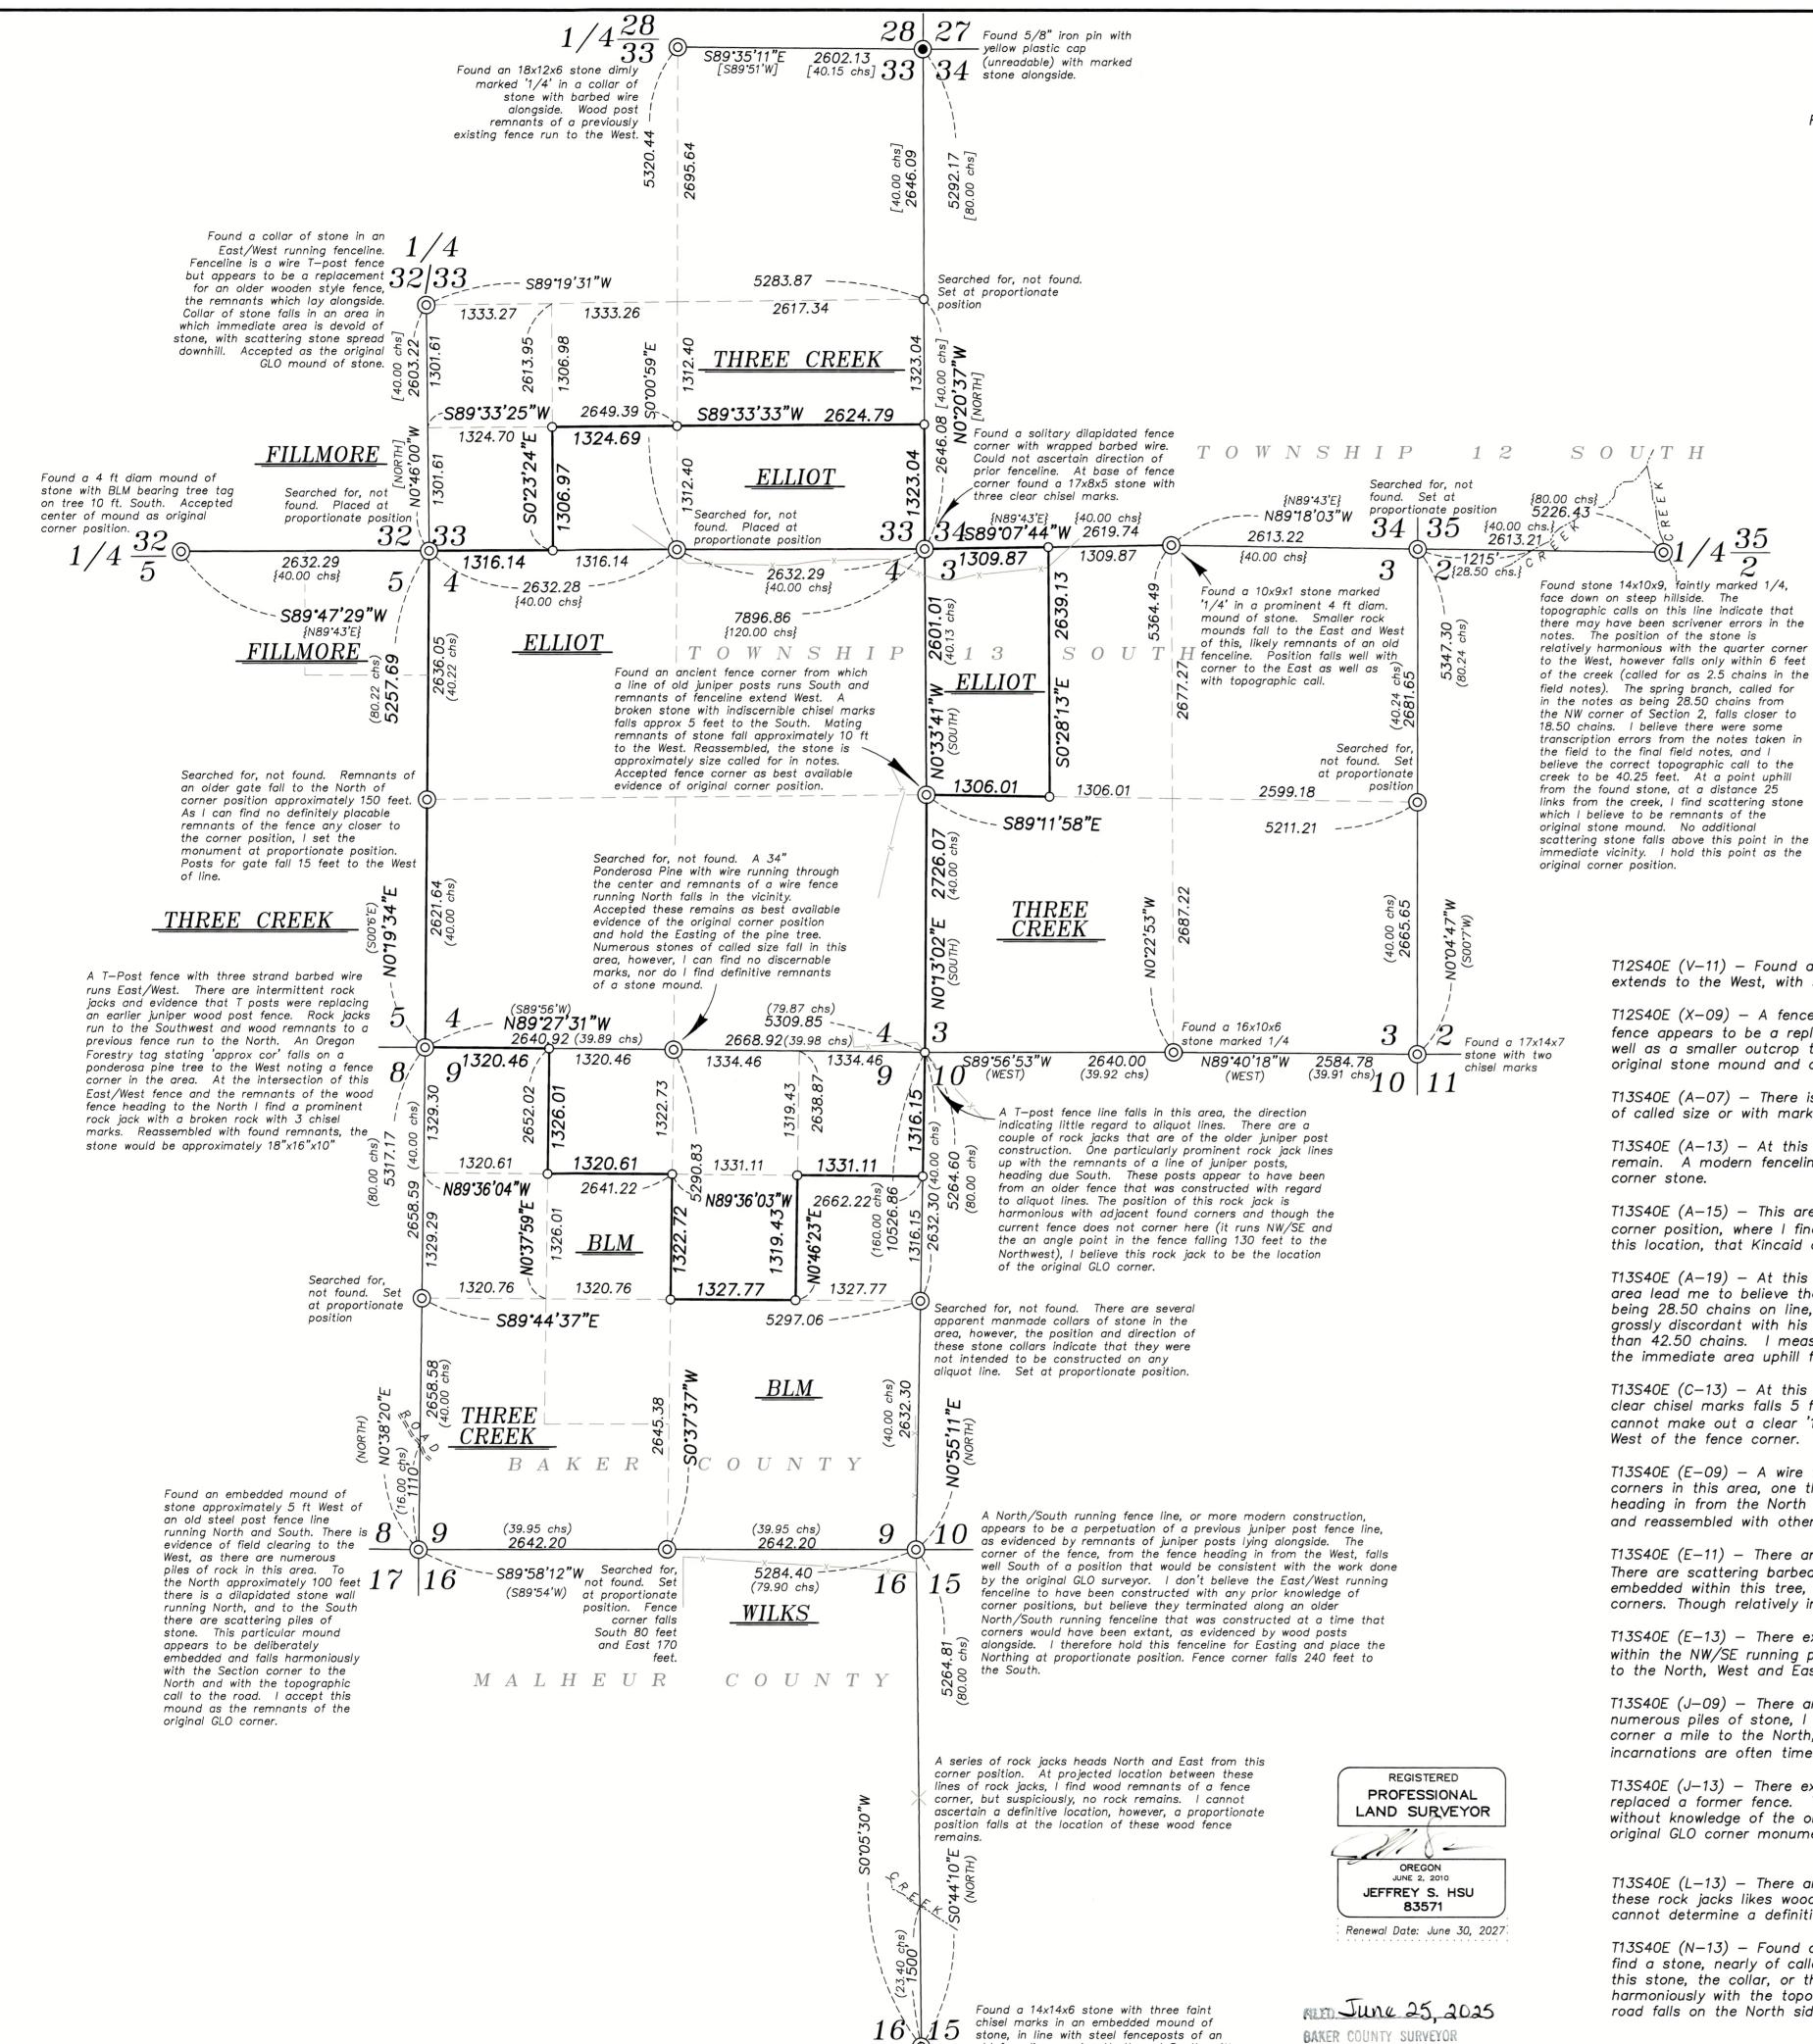
SCALE: 1"=1000'

Found 5/8" iron pin with yellow plastic cap (illegible), set by Survey Number 12-40-13

Set $5/8" \times 30"$ iron pin with 2 1/2" aluminum cap, marked as per monumentation

Set 2 1/2"x30" aluminum pipe with 3" aluminum cap, marked as per

monumentation record, filed separately

Fenceline

record, filed separately

Record measurement as per GLO Contract No. 409, dated August 22, 1881, executed by George Henderson

Record measurement as per GLO Contract No. GLO Contract No. 140, dated May 17. 1871. executed by John S. Kincaid

Record measurement as per GLO Contract No. 148, dated May 18, 1871, executed by John S. Kincaid

This survey was done at the request of Sam Martin, manager of lands owned by Three Creek Ranch. Mr. Martin wanted select corners set prior to fencing. Township 13 South, Range 40 East was originally surveyed by GLO surveyor John Kincaid. No subsequent records or retracements within this Township were found within the County Surveyor records of Baker or Malheur counties. In my retracement of Kincaid, I find there to be numerous inconsistencies with regard to stone sizes, chisel marks, and topographic calls. Found stone corners which bear clear definitive chisel marks are grossly undersized. And stones of called size generally bear faint, incomplete, or nonexistent marks. Due to the fact that in some of the locations of the undersized stones, that there would be very little reason to choose a stone of such size, I can only ascertain that the undersized stones were chiseled in the comforts of camp and transported to the location that they were ultimately set, while corners set from stones found in the immediate area were more poorly marked, if marked at all.

The subdivision of Township 12 South, Range 40 East was surveyed by GLO Surveyor George Henderson. It is notable that Henderson also found Kincaid's stones to be of a smaller size than called for in his notes.

Subdivision of sections is done as per BLM Manual of Instruction 2009. I find no other unusual conditions with this survey.

T12S40E (V-11) - Found an 18x12x6 inch stone marked '1/4'. This stone falls in a collar of stone with barbed wire and was likely an old fence corner. From this point a series of old wooden posts extends to the West, with scattering barbed wire alongside. This fence is of a vintage that current landowners were seemingly unaware of its presence.

T12S40E (X-09) - A fenceline runs East/West in this area. Fence is a three stand barbed wire fence of T-post construction. Older wooden fenceposts lie on either side of the fence, and the T-post fence appears to be a replacement of this older wooden fence. I find a collar of stone with scattering stones laying downhill (North). There is a rock outcrop several hundred feet to the Northeast as well as a smaller outcrop to the West, however within the immediate vicinity of this collar, there do not appear to be many stones on the uphill or sidehill sides. I believe this to be remnants of the original stone mound and accept it as the best available evidence of the original corner position.

T13S40E (A-19) - At this location, I find a stone of called size, marked '1/4'. This stone is face down on a steep hillside falling approximately 6 feet from the creek. The topographic calls in this area lead me to believe that there may have been some transcription errors between the field notes taken in the field and the final field notes submitted to the GLO. The spring branch, indicated as being 28.50 chains on line, falls close to a 18.50 chains. The topographic call to the creek East of this quarter corner is noted as being 42.50 chains on line. I find that a position 2.50 chains to be grossly discordant with his other corner location on the township line and I believe a scrivener error also was made on this call. It is highly likely that the call was intended to be 40.25 chains rather than 42.50 chains. I measure a point from the creek, uphill through the found stone, 0.25 chains and find that there are scattering stones falling on the downhill side of this point, but no stones in the immediate area uphill from this point. I believe these stones to be remnants of the original stone mound, and hold this point as the location of the original corner position.

T13S40E (C-13) — At this position, I find a dilapidated fence corner with a row of juniper fence posts heading South, with wire alongside. The posts terminate at a point where a broken stone with clear chisel marks falls 5 ft. South. This stone is broken, and remnants falls approximately 10 feet to the West. Collectively, they make up a stone of called size. Chisel marks are clear, however, I cannot make out a clear '1/4'. There are scattering bits of barbed wire heading to the West where it meets with a prominent rock jack that comprise the modern day fence, approximately 230 feet West of the fence corner. I accept this this fence corner at the Northern terminus of this line of juniper fence posts as the original corner position.

T13S40E (E-09) - A wire fence runs East and West through this corner position, with juniper posts lying alongside, and some juniper posts still erect in the fence. There is evidence of two fence corners in this area, one that heads North, evidenced by old wood posts, and one that heads to the Southwest, evidenced by old rock jacks, through they terminate at different locations. The fence heading in from the North terminates at a prominent rock mound, where I find an undersized stone with three chisel marks lying loosely amongst the stones. This stone appears to have been broken and reassembled with other fragments, the stone appears to have been 18"x16"x10". Despite having the incorrect number of marks, I accept the location of this rock jack as the original corner position.

T13S40E (J-13) — There exists a fence corner in this area, from which fences bears North and West. The fence running North/South show evidence of older wooden fence posts, indicating it likely replaced a former fence. The corner of this fence falls grossly out of position from record measurements as per the GLO field notes, and I believe the portion of this fence running West was done without knowledge of the original GLO corner, and was likely built only as a fenceline of convenience, terminating on the East side at the older wooden fence, which I believe was built with regard to the original GLO corner monuments. I therefore hold the Easting of the fenceline and use a proprtionate position for the Northina.
