Survey Number 12-40-13

Field Notes for GLO Contract No. 409, dated August 22, 1881, executed by George Henderson

NARRATIVE

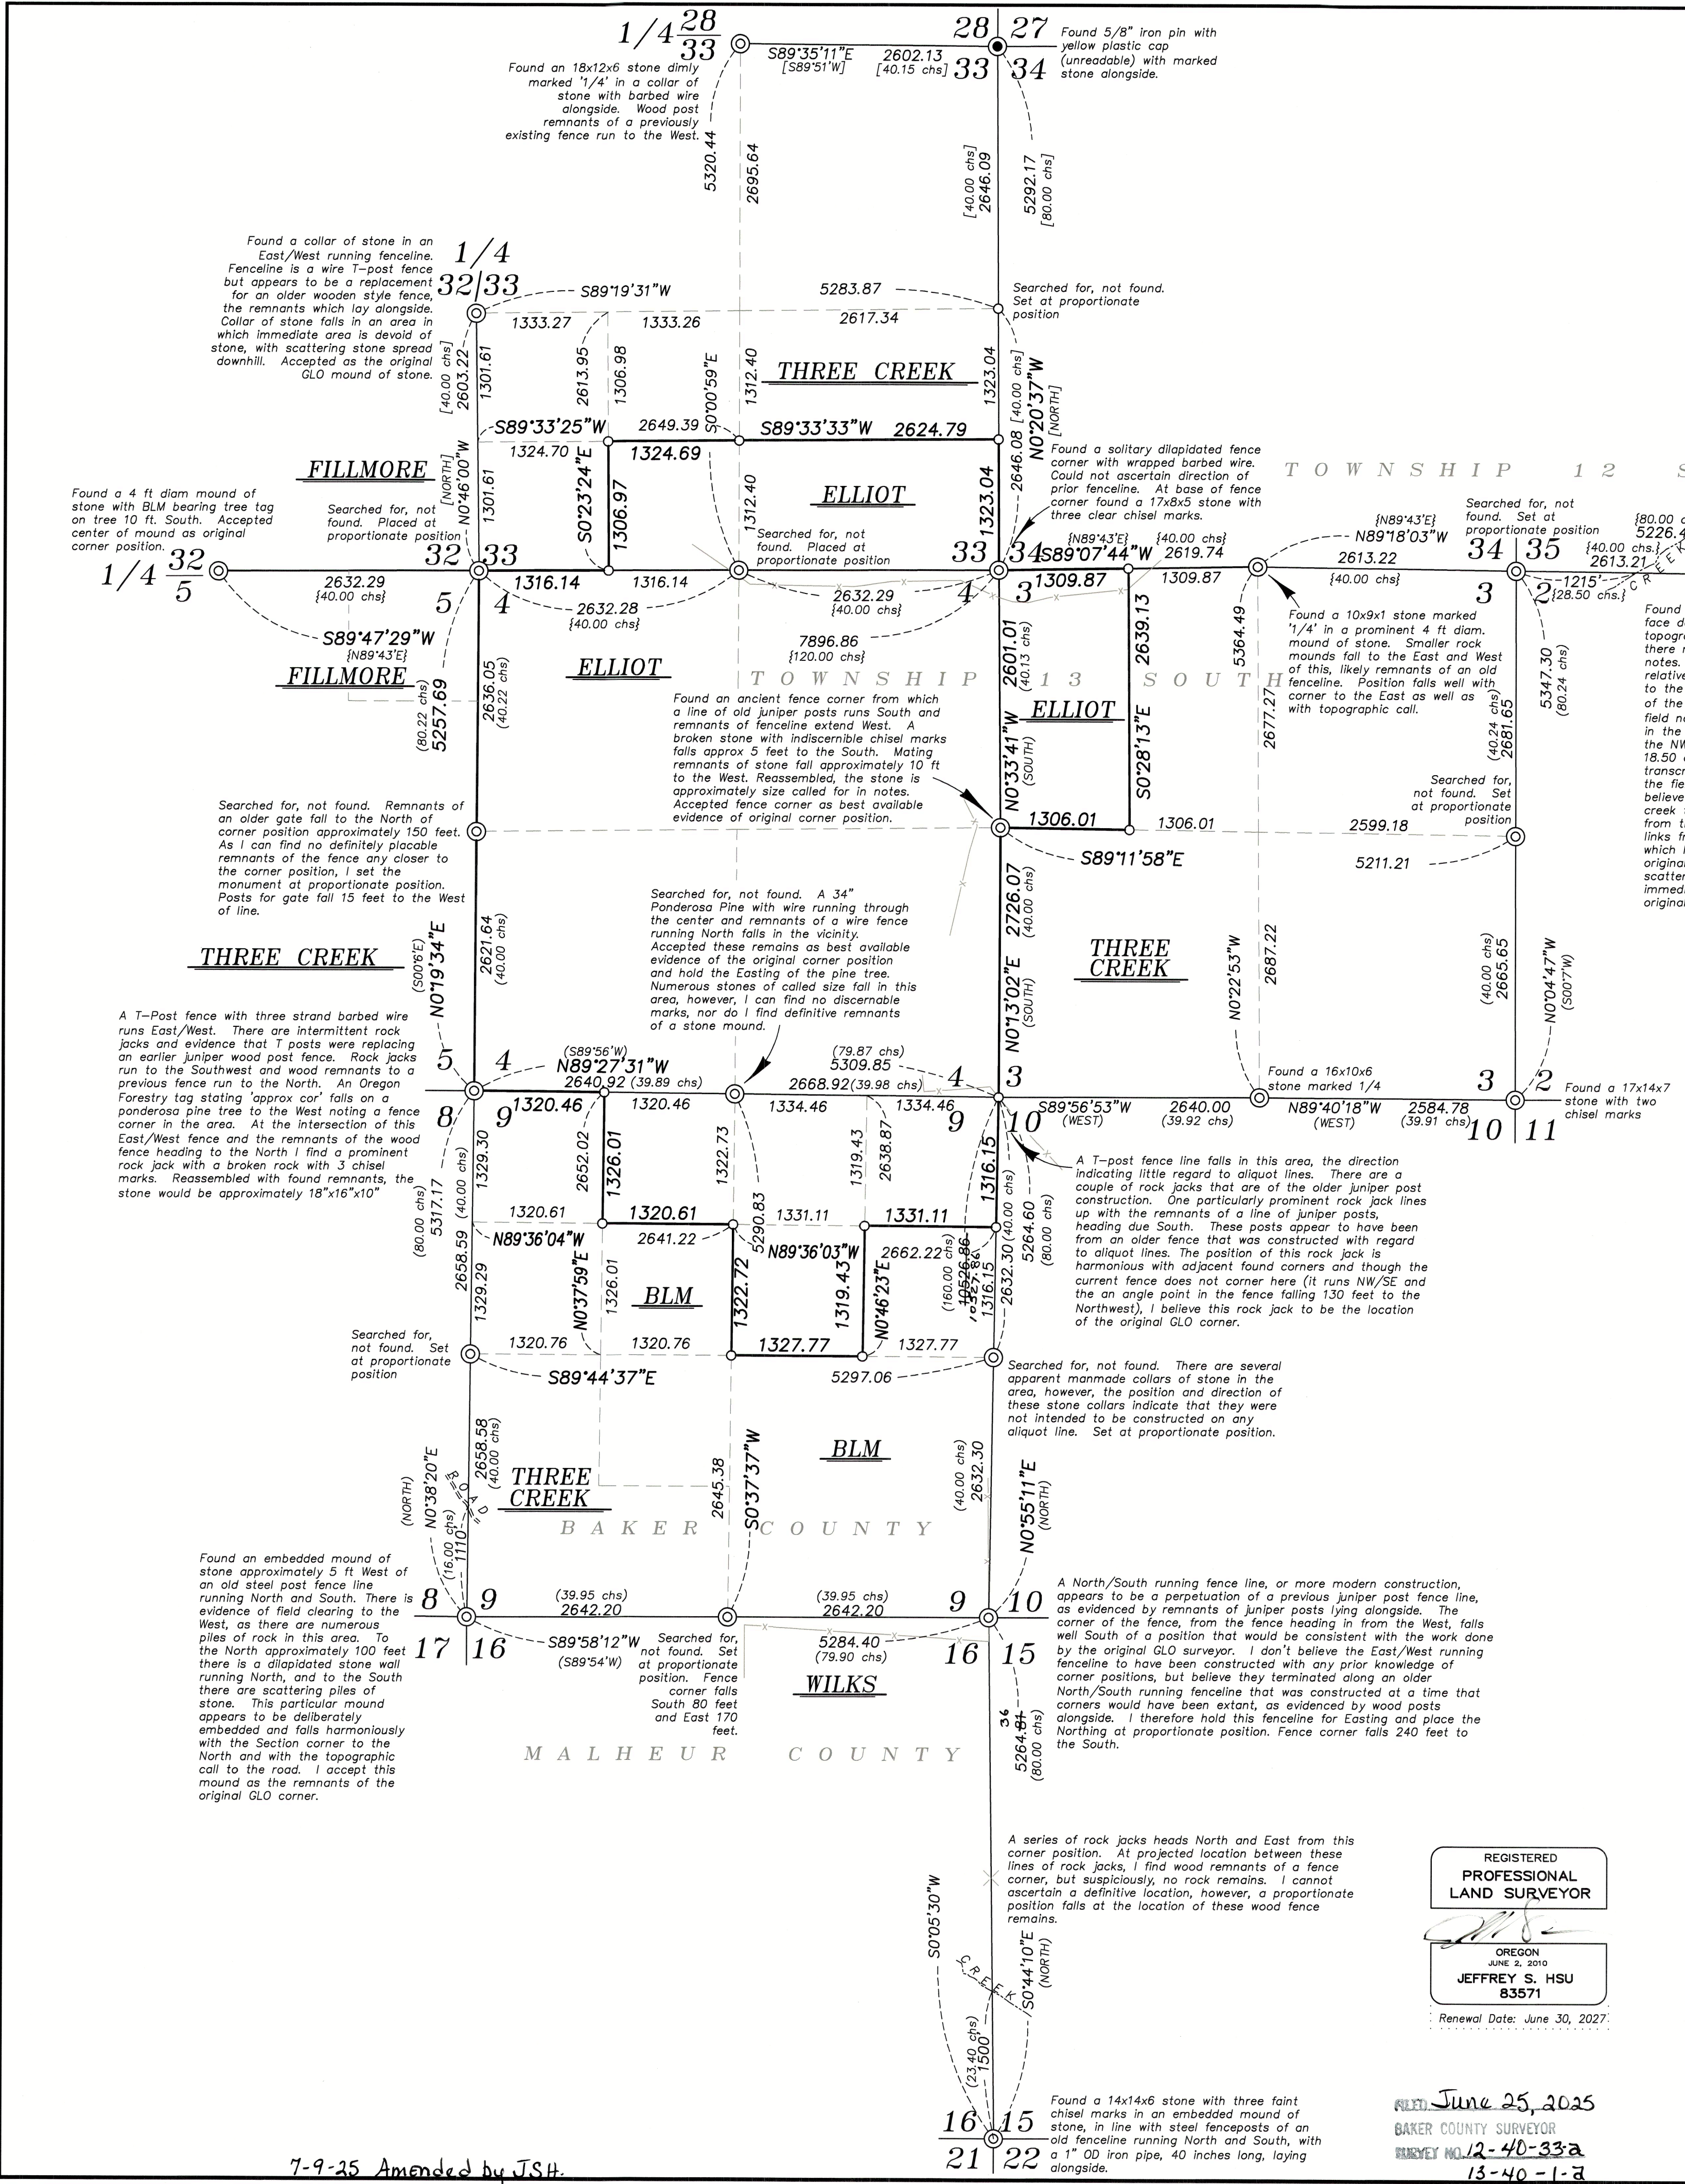
SCALE: 1"=1000'

- Found 5/8" iron pin with yellow plastic cap (illegible), set by Survey Number 12-40-13
- Set 5/8"x30" iron pin with 2 1/2" aluminum cap, marked as per monumentation record, filed separately
- Set 2 1/2"x30" aluminum pipe with 3" aluminum cap, marked as per monumentation record, filed separately
- Fenceline
- Record measurement as per GLO Contract No. 409, dated August 22, 1881, executed by George Henderson
- Record measurement as per GLO Contract No. GLO Contract No. 140, dated May 17, 1871, executed by John S. Kincaid
- Record measurement as per GLO Contract No. 148, dated May 18, 1871, executed by John S. Kincaid

This survey was done at the request of Sam Martin, manager of lands owned by Three Creek Ranch. Mr. Martin wanted select corners set prior to fencing. Township 13 South, Range 40 East was originally surveyed by GLO surveyor John Kincaid. No subsequent records or retracements within this Township were found within the County Surveyor records of Baker or Malheur counties. In my retracement of Kincaid, I find there to be numerous inconsistencies with regard to stone sizes, chisel marks, and topographic calls. Found stone corners which bear clear definitive chisel marks are grossly undersized. And stones of called size generally bear faint, incomplete, or nonexistent marks. Due to the fact that in some of the locations of the undersized stones, that there would be very little reason to choose a stone of such size, I can only ascertain that the undersized stones were chiseled in the comforts of camp and transported to the location that they were ultimately set, while corners set from stones found in the immediate area were more poorly marked, if marked at all.

Subdivision of sections is done as per BLM Manual of Instruction 2009. I find no other unusual conditions with this survey.
