CERTIFIED RECORD OF LAND CORNER MONUMENTATION

FILED AUG. 1, 1997 AKER COUNTY SURVEYOR SURVEY NO. 9-37-25

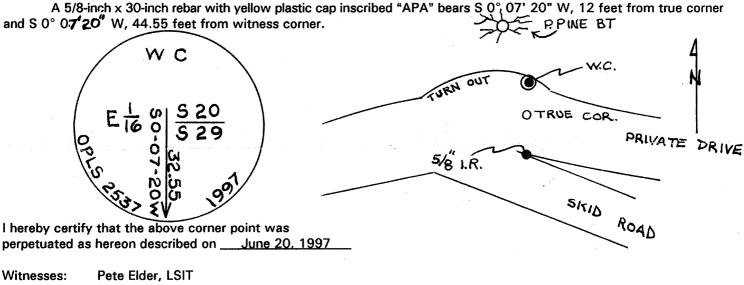
Due to apparent ongoing grading activity, a witness corner was set on the side of the road. This monument is a 2-1/2-inch aluminum cap on a 2-1/2-inch x 30-inch aluminum pipe in a mound of stone, stamped as shown below, bears N.0° 07' 20" E., 32.55 feet from the true corner.
