# RECORD OF LAND CORNER MONUMENTATION

SOUTH 1/16 CORNER SECTION 29, T. 9 S., R. 39 E., W.M.

FILED December 9, 2020  
BAKER COUNTY SURVEYOR  
SURVEY NO. 9-39-313

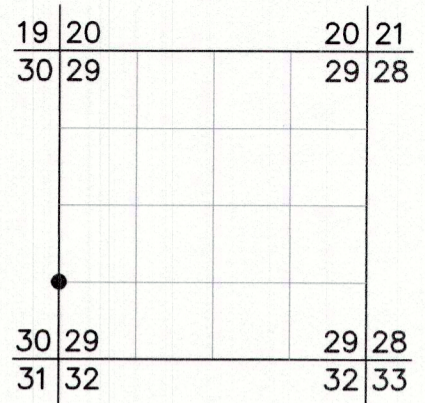
**EVIDENCE FOUND:** Found the steel fence post with sign attached, set near the corner position. Also found a 23" dbh ponderosa pine with healed blaze. The bearing tree also had a BLM BT tag and Hanley's BT tag attached. Found dead and down remains of the fir bearing tree lying 20 feet South (downhill). I determined the position of the 1/16 corner at record bearing and distance from the remaining bearing tree.

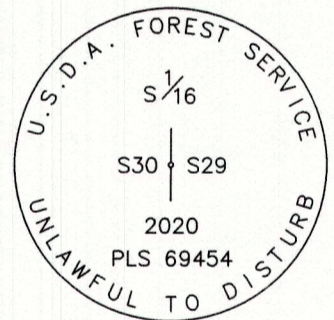
CORNER MONUMENT MARKED:

**DESCRIPTION OF MONUMENTS AND ACCESSORIES SET AND METHODS USED:**  
At the corner point, I set a 5/8"x36" iron pin 36" in the ground with attached 3¼" USFS brass cap. Surrounded the pin with a 1 ft. diameter collar of stone. Cap is marked as shown.
